In-Depth Analysis, Testing Yield Cause of High Hydrocarbon Failure

This is a story of a 1994 GMC Vandura with a 305 V-8, throttle body fuel injection, and 95,930 miles on the odometer. This vehicle had failed the emissions test for high HC. A registered repair shop performed all normal diagnostics, but could not pinpoint the problem. The shop then sought the assistance of Agbar's West Springfield Diagnostic and Training Center (DTC).

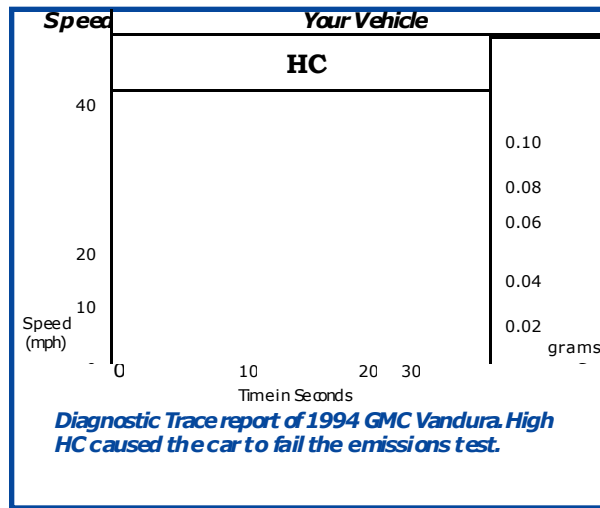
First, we ran a Mass 99 diagnostic trace to confirm the failure. As you can see on the report, the HC was very high at the beginning of the "cruise" and at the deceleration portion of the drive trace. Carbon monoxide (CO) and nitrogen oxide (NOx) were low.

Looking at the initial results, HC spiked right at the deceleration curve. This would make one think it could be an oil consumption issue — in other words, faulty intake valve seals or faulty guides

Although CO was within specifications, it did spike to .6 grams per second at approximately 23-25 seconds of the drive trace. Because the CO spike occurred in the drive trace, we decided to look into something else that could be causing this condition at idle: EGR operation.

After replacing the valve and verifying that all the ports were clean, the vehicle was retested and passed the emissions test.
